Report No. UT-00.13

***STATIC AND DYNAMIC
TESTING OF A CURVED,
STEEL GIRDER BRIDGE IN
SALT LAKE CITY, UTAH***

FINAL REPORT

**Utah Department of Transportation
Research Division**

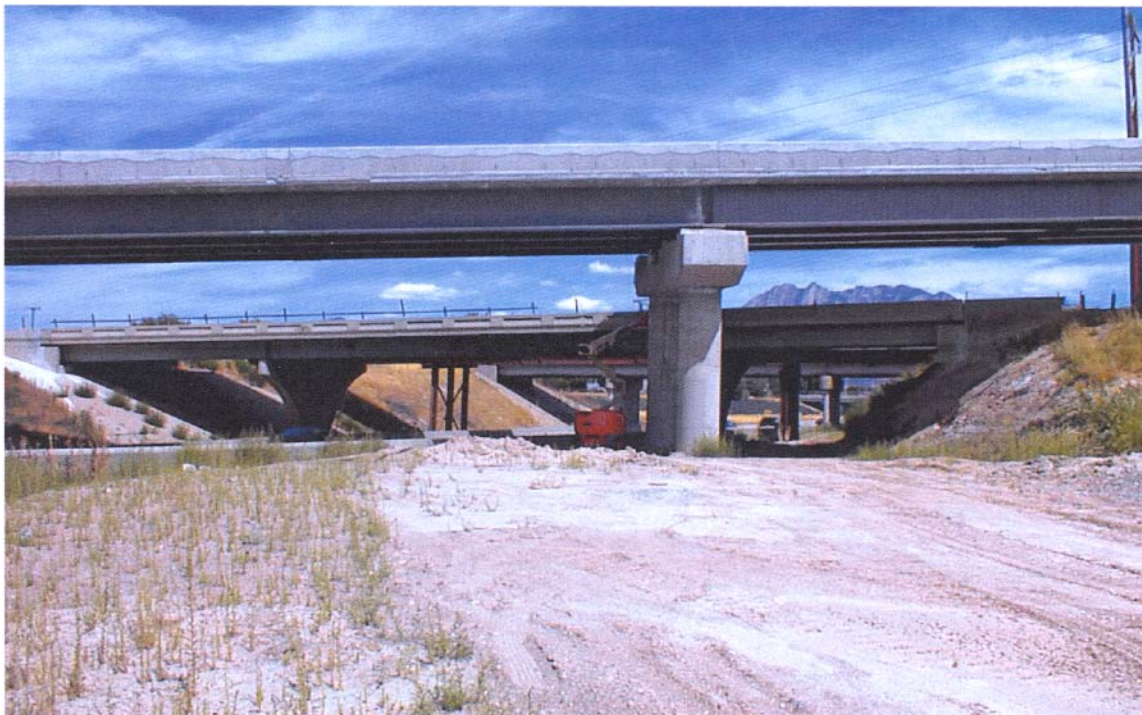
Figure 1. Northbound 1-15 Ramps to Westbound 1-215

The curved bridge tested on the 1-15 corridor in Salt Lake City was built in the early 1970's and was located at the southern interchange of 1-15 and 1-215, it carried northbound traffic from 1-15 to the westbound lanes of 1-215. This bridge, the second bridge seen in Figure 1, was out of commission for almost a year before demolition and was replaced by a much longer bridge (foremost bridge in Figure 1).

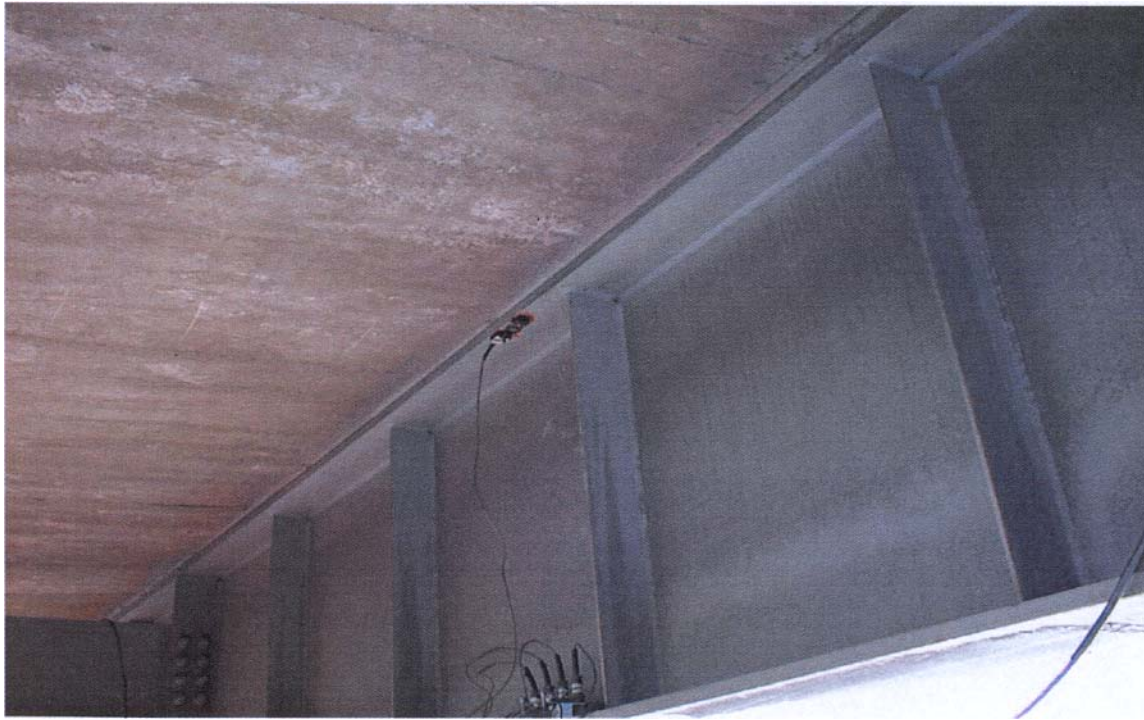
Figure 6. Close-up View of Bridge Underside

The overall condition of the bridge deck and steel support girders was very good, with no decay of the concrete on the underside of the deck and very little corrosion of the steel girders (see Figure 6).

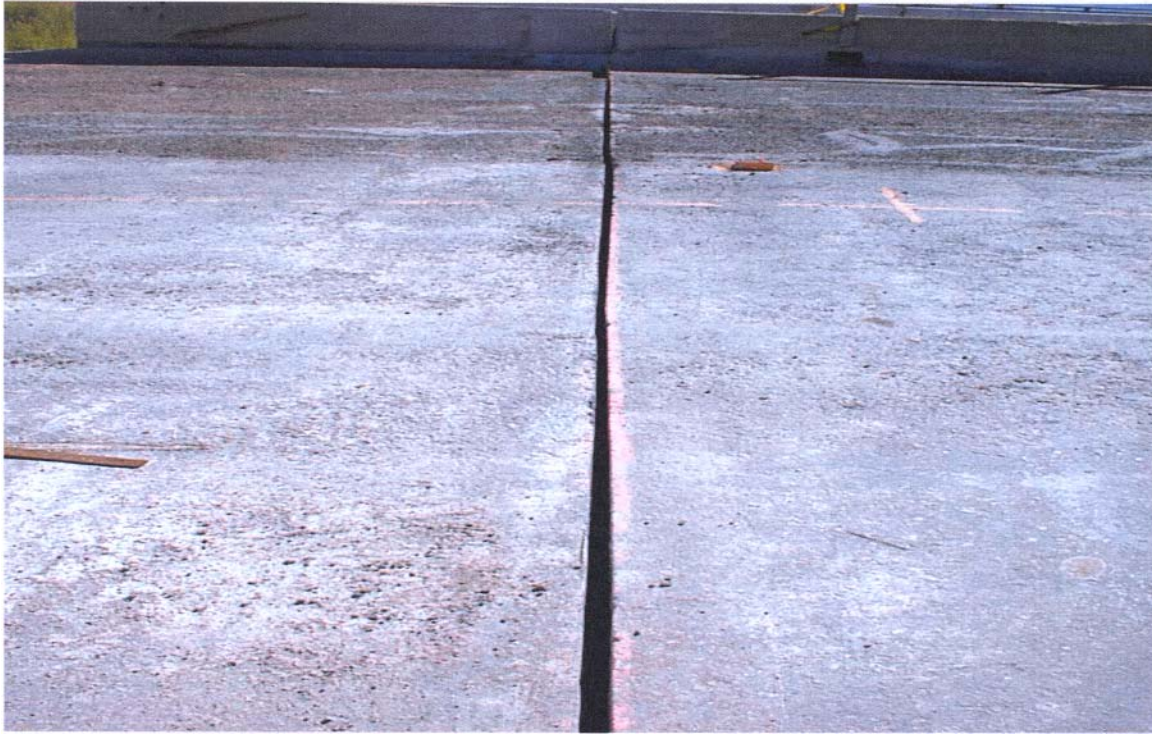
Figure 7. Cut Separating Bridge Deck and Abutment

For the second phase of the testing the integral deck and abutment were separated by cutting the deck (see Figure 7). The intent was to "free" up the end boundary conditions. The change in boundary conditions for the third phase of testing consisted of jacking up the support girders at the abutments, taking the girder ends off of the bronze bearings and placing them on frictionless stainless steel bearings and a neoprene pad (see Figure 8). In addition to this, the girders over the piers were jacked up and the bearings greased. The objective was to get bearings at the abutments and on the piers that actually worked.
